# Manhole Inspection Summary

Manhole # S19W\_\_016MH

Insp Date: **6/27/08 11:57 AM**

**Location** Address: **1820 spence st** Cross Street: **washington bd**

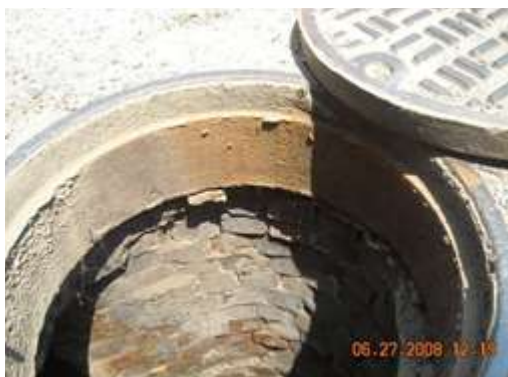
Misc

**Manhole** Type: **Inline** Location: **Roadway** Ground Conditions: **Dry**  
☐ Prev. Rehab Weather: **Dry** Subject To Ponding: **Sheeting**

inflow evidence from sheeting

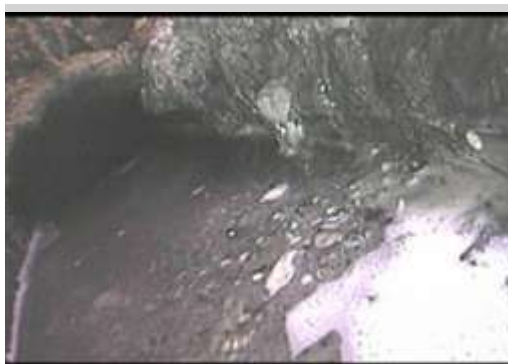
Defect 7

Condition: ☐ Sound ☐ Cracked ☐ Root Intrusion ☐ Deteriorated ☐ Leaks ☒ **Debris**

debris in channel

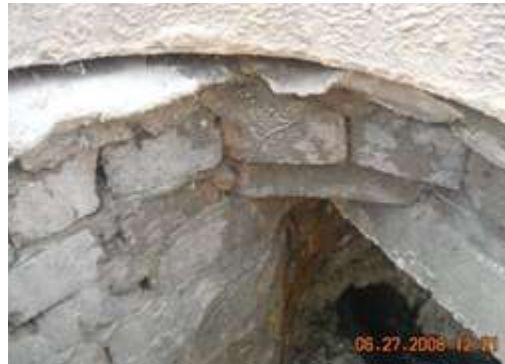
Defect 6

Infiltration: ☐ None ☒ **Joint** ☐ Cracks ☐ Mortar ☐ Roots ☐ Wall

infiltration @ chimney/frame joint

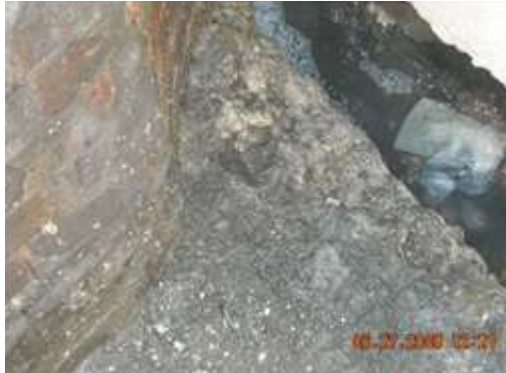
Defect 5

Condition: ☐ Sound ☐ Cracked ☐ Root Intrusion ☐ Deteriorated ☐ Leaks ☒ **Debris**

debris/grease on bench

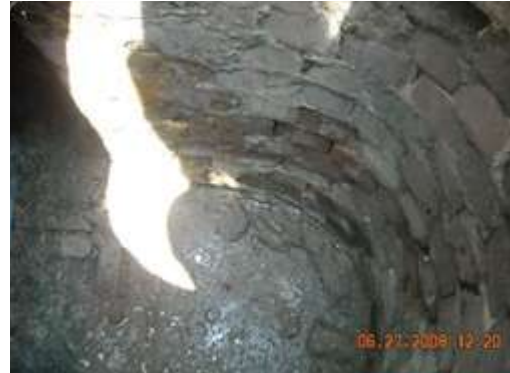
Defect 4

Infiltration: ☐ None ☐ Joint ☐ Cracks ☐ Mortar ☐ Roots ☒ **Wall**

infiltration @ barrel wall

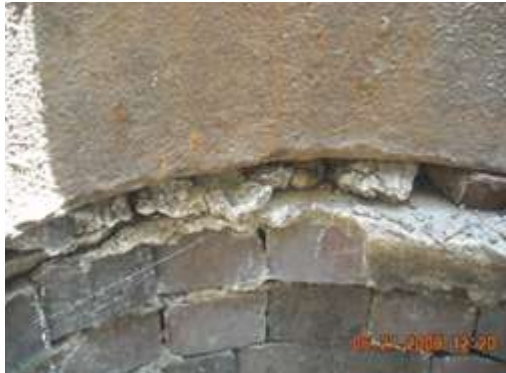
Defect 3

Condition: ☐ Sound ☐ Cracked ☐ Root Intrusion ☐ Loose Brick ☒ **Deteriorated**

deteriorated chimney

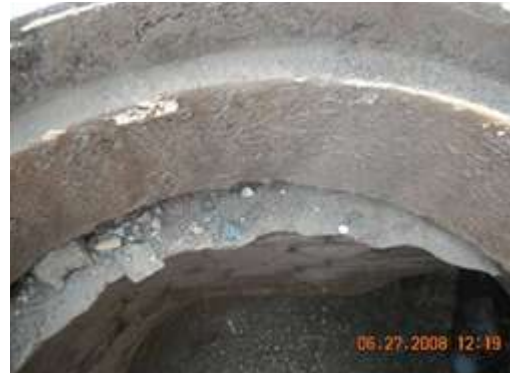
Defect 1

**Frame** Offset: **1** (in.) Condition: ☒ Sound ☐ Cracked ☐ Leaks

frame offset

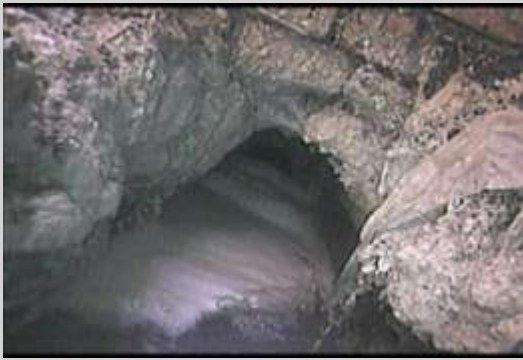
12 O'Clock Outflow

8 in. Circular Gravity Sewer  
Pipe Out @ 12 O'Clock

Pipe Height: **8.4** (in.) Rod and Bar (Angled)  
Pipe Material: **Clay** ☐ Pipe Lined  
Invert Depth: **4.90** (ft.) Flow Characteristics: **Slow**  
Deposits: ☐ None ☒ **Mud** ☒ **Grassy** ☐ Debris ☒ **Grease**  
Silt Depth: **3** (in.) Deposits Extent: **Medium**  
Infiltration: **None** Pipe Seal Cond: **Unknown**

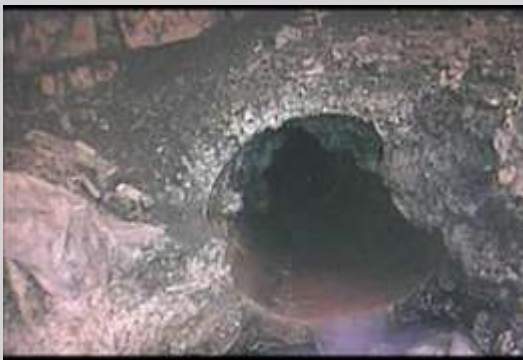
3 O'Clock Inflow

8 in. Circular Gravity Sewer  
Pipe In @ 3 O'Clock

Pipe Height: **8.4** (in.) Rod and Bar (Angled)  
Pipe Material: **Clay** ☐ Pipe Lined  
Invert Depth: **4.60** (ft.) Flow Characteristics: **Slow**  
Deposits: ☐ None ☐ **Mud** ☐ **Grassy** ☐ Debris ☒ **Grease**  
Silt Depth: **2** (in.) Deposits Extent: **Light**  
Infiltration: **None** Pipe Seal Cond: **Unknown**

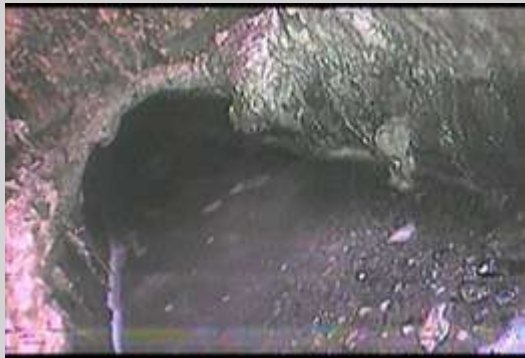
6 O'Clock Inflow

8 in. Circular Gravity Sewer  
Pipe In @ 6 OClock

Pipe Height: **8.4** (in.) Rod and Bar (Angled)  
Pipe Material: **Clay** ☐ Pipe Lined  
Invert Depth: **4.75** (ft.) Flow Characteristics: **Slow**  
Deposits: ☐ None ☒ **Mud** ☒ **Sludge** ☐ Debris ☐ Grease  
Silt Depth: **3** (in.) Deposits Extent: **Medium**  
Infiltration: **None** Pipe Seal Cond: **Unknown**
